CASE STUDY

Project name: Hatters New Block Paved Car Park.
Client: Hatters Fine Furnishings
Contractor: As above
Site: Car park in front of Hatters New Showroom - Goldington Road, Bedford
Project: Deep clean 1750m² new paving & rejoin. Apply QSET to stabilise joint material.
Product/s used: QSet
Date: Jan 2004 & Feb 2009

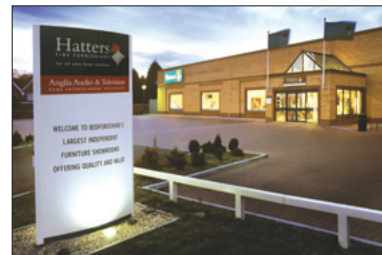
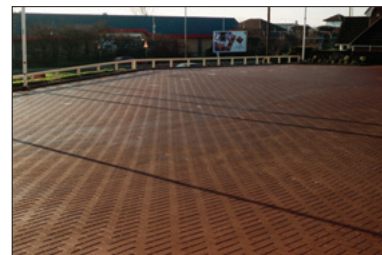
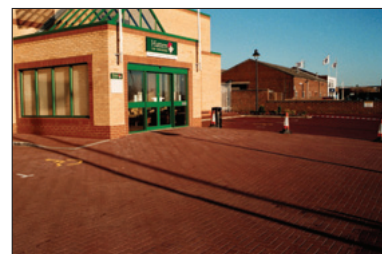
There was evidence of erosion and loss of blocks pavers due to destabilised joint sand with unsightly weeds, moss and oil stains tarnishing the surface. The client was struggling to keep the area to an acceptable standard cost effectively.

Whole site was deep cleaned and brought back to new condition then resanded. Finally, QSet was applied to stabilise all the joint material and improve the protective nature of the finish.

The site has continued to be regularly monitored by QSS for over 5 years and the Qseal treatment has proved highly effective, providing the stabilisation required along with a much higher standard of appearance with minimal cleaning investment.
