## CASE STUDY

**Project name:** Prevention of trip & missile risks  
**Client:** Bedford Borough Council  
**Contractor:** Stacey Construction (Mike Stacey Group)  
**Site:** Lime & Harpur Street's - Bedford  
**Project:** Strengthening & rebuilding  
50 paved highway manhole covers  
**Product/s used:** Polycote 2 pack  
**Date:** September 2009

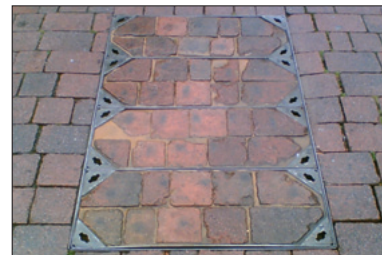
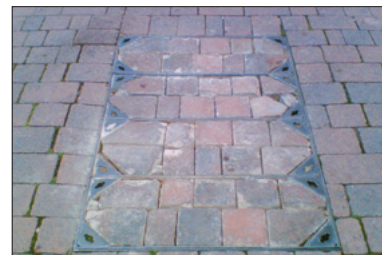
The standard manhole cover trays had become seriously damaged by vehicle weight and manoeuvring.

Many had sunk causing the paving to become completely destabilised and creating trip and block fragmentation problems with resulting damage to other property.

The treatment has been to remove the relevant trays in small batches (4 to 6 at a time), fitting steel chequer plate temporary covers to enable repairs to the trays, and the new jointing material to cure overnight.

The existing paving is removed from the cover and the sides and base are rotary wire brushed to remove all surplus material. Trays are inspected, re-welded and strengthened as necessary.

3-4 mm dried aggregate is mixed with Polycote heavy duty 2-pack resin and then this is laid in the base of the pre primed tray to form the support for the block paving elements.

The paving elements are suitably primed on each base and sides to ensure adhesion to the aggregate. The paving elements are then repositioned into the trays and they bond to the aggregate base.

Next the vacant joints are filled almost up to the level of the paving elements with Kiln dried sand. The 2 pack clear HD resin is then slowly applied until all the joint sand is saturated and left to cure. The trays are then relocated in the relevant manhole cover support frame.
